A-TIA19_04-GB

Amendment of the original operating instructions

Inspection of the bolted connection of the worm wheel of the elevator machines ZAS0, ZAS1, ZAS2, ZAS3

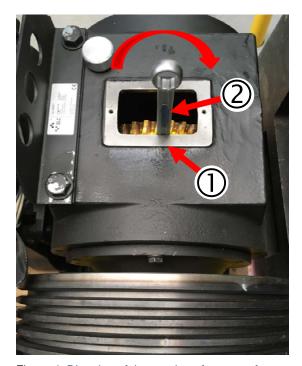
Apply the suitable tool (2) onto the nut (1) of the bolted connection and turn clockwise with moderate force according to the following table without any jerk.

Figure 4: Direction of the rotation of spanner for inspection of tightening the nuts

If it is possible to turn a nut on the fitting bolt, or the whole connection of the nut and the fitting bolt, the screw connection has to be considered as inadequately.

If just one of 6 connections is considered as inadequately, the elevator machine has to be taken out of order immediately and permanently. The elevator has to be secured against restart.
