A-TIA19_04-GB

Amendment of the original operating instructions

Inspection of the bolted connection of the worm wheel of the elevator machines ZAS0, ZAS1, ZAS2, ZAS3

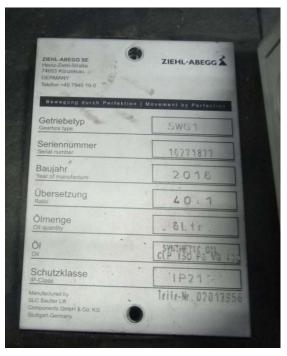
Figure 1: Name plate with removed bolts M6

Remove the name plate with the sealing, on the top of the gearbox by removing both hexagon bolts M6.

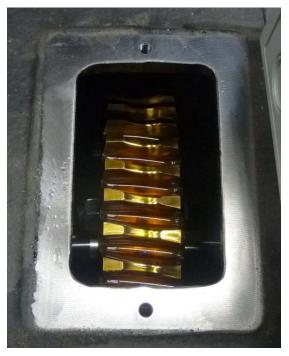
Figure 2: Maintenance hole with removed name plate

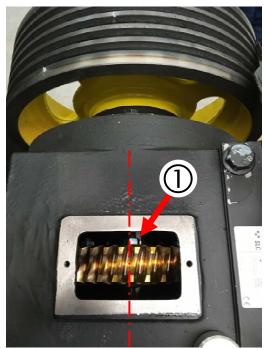
Figure 3: Target position of the bolts for inspection

Each nut (1) which has to be inspected should preferably be located in the center of the maintenance hole.

If this is not the case, then bring the nuts into position, one by one for the inspection, in according to point 2.3.3 – inspection of tightening.

It is recommended to mark the traction sheave with a coloured marking to avoid that the inspection of any nut is missing.

The positioning of the worm wheel should be done by using the inspection control.
